Solutions for the Rehabilitation of Historical Building Facades with Local Materials

In order to demonstrate the level of deterioration of the historical facades [8] in the centre of Chisinau, a study was carried out on the building of the former community of medical sisters “Red Cross from Harbovat Monastery”.

The building of the former community of medical sisters “Red Cross of Harbovat Monastery”, an architectural monument of national significance, which was built in 1905-1910, made of limestone with the architecture of the building made in modern style, with details specific to the eclectic style.

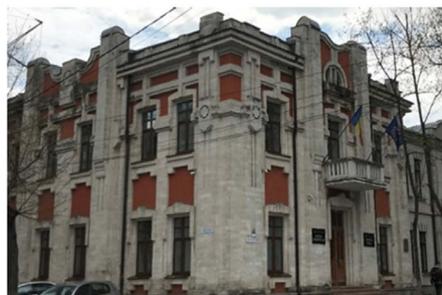
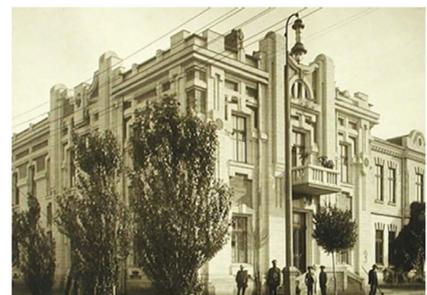
Figure 1. broadcasting co-ordinator council building.

Specific elements of the modern style facade are the striations on the surface of the columns, the combination of building materials of different colours and compositions, burnt brick and limestone, the latter being used as an anchor on the brick background.

Present

Passed

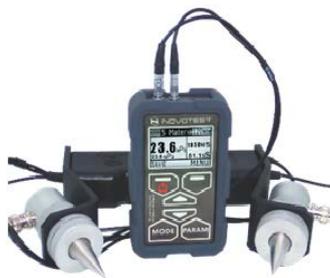
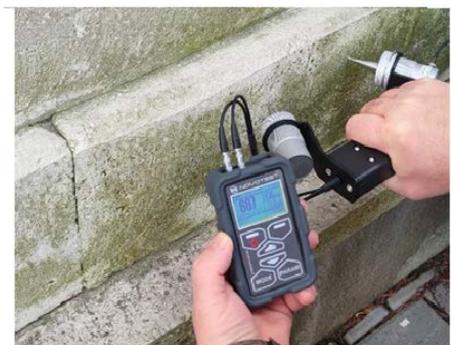
Figure 2. Ultrasonic pulse velocity tester.

Using the ultrasonic device shown in **Figure 2**, façade degradations were determined by a visualization of the received ultrasonic waves, which has an oscilloscope mode to visualize and analyse the A signals. This apparatus allowed the determination of gaps, cracks and other internal defects that occurred during operation.

Equipment such as a professional camera, a laser ruler for accurate size determination and an ultrasonic tester was used for the non-destructive visual inspection [9] [10] [11] [12].

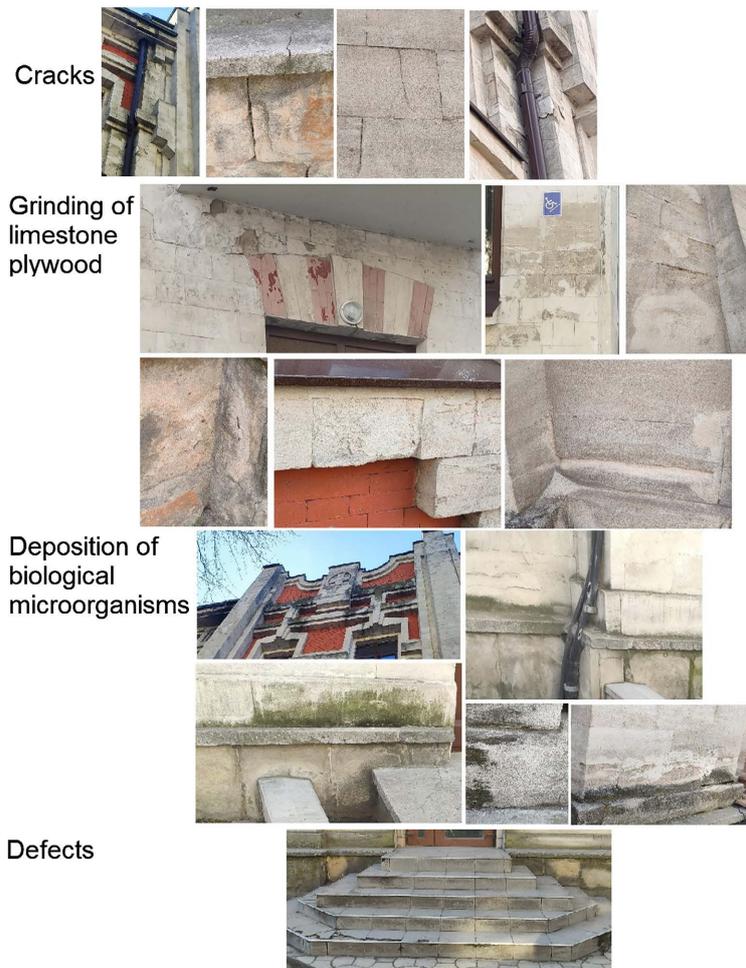
Figure 3. Results of the visual inspection of the building façade.

Following the expertise of the facade of the building at 46 Vlaicu Pârcălab Street, cracks, deposits of biological microorganisms, degradation of the limestone plywood and other degradation of architectural elements were determined and are presented in **Figure 3**.

4) The reconstruction and rehabilitation of the “Building of the former community of the Red Cross medical sisters of the Harbovat monastery” on 46 Vlaicu Parcalab Street is a necessity, which was identified after the on-site inspection and the researchers recommend starting the renovation as soon as possible.

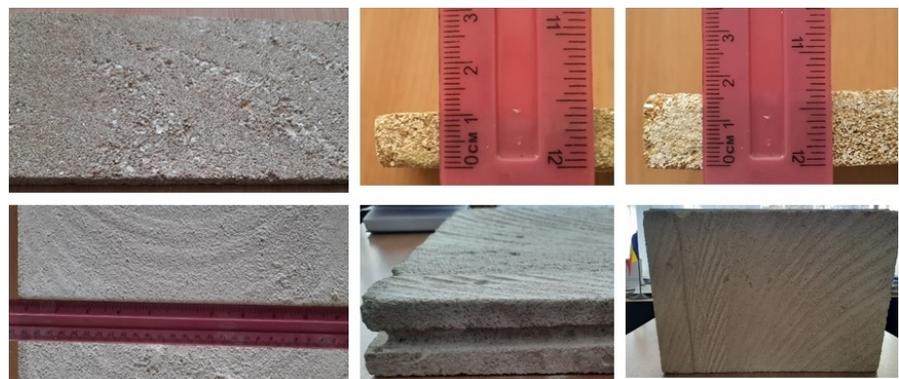
Figure 4. Limestone cladding for facade rehabilitation.

Figure 4 shows models of limestone slabs that can be used to rehabilitate the facades of historic buildings. The thickness of the plywood varies from 1 cm to

1.5 cm, also the limestone plywood is processed and has low water absorption.

- 1) Removal of the old layer by cleaning (washing with water jet, high pressure), degreasing and sanding of the masonry from cut limestone blocks;
- 2) Filling joints with mortar, identical to that used for masonry, decorative element or cladding;
- 3) Replacing damaged or crushed limestone blocks by cutting them on-site, following their dimensions and configuration, preventively reinforcing and reinforcing (*if necessary*) the contact surface;
- 4) Restoration or replacement of the decorative limestone element, preventively strengthening and reinforcing (*if necessary*) the contact surface;
- 5) Final cleaning of masonry, cladding and decorative limestone elements by sanding;
- 6) Vacuuming limestone dust from the façade surface [15].

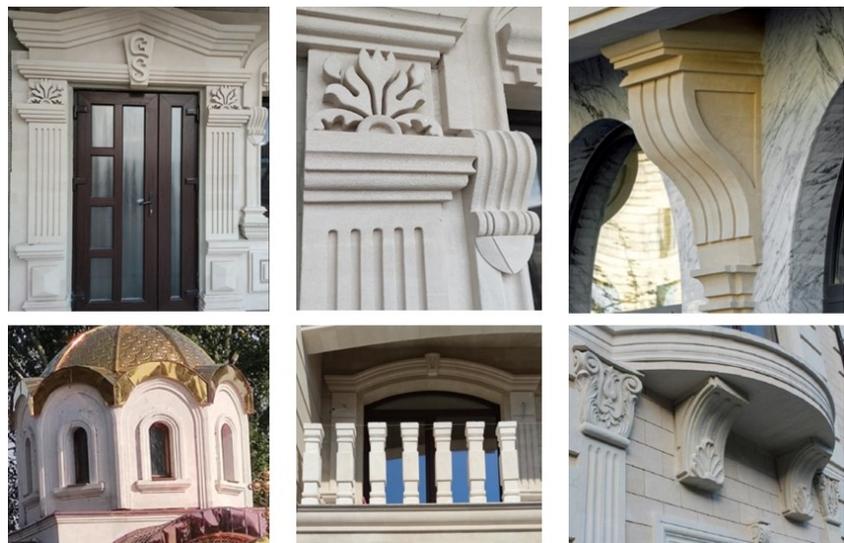
Figure 5. Limestone decoration elements for facade rehabilitation.

Figure 5 shows limestone plywood patterns that have been handcrafted by carvers to arrive at that identical architectural element for the rehabilitation of the façade of the historic building.

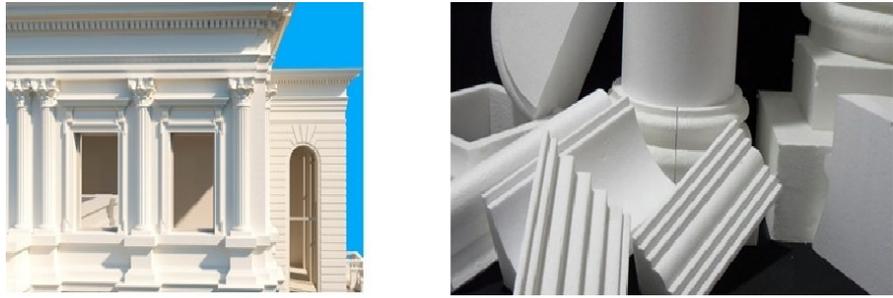
Figure 6. Polystyrene decoration elements for facades.

Another method of facade rehabilitation may be to replace limestone plywood with modern materials at the expense of the authenticity of the materials from which the decorative elements are made. Decorative elements are made of polystyrene, which is a high-pressure resistant, non-water-absorbing, easy to process and easy to use material that is easily bonded to any type of surface, are presented in **Figure 6**.

Three-dimensional cutting of polystyrene elements of any complexity, this is an important reason for its widespread use in restoring the image of historic buildings. Practical and economical materials are preferred for carrying out decoration-finishing works, this can be designed and carried out based on photographs of architectural elements of historical buildings.

- 1) Removal of all existing plywood;
- 2) Wall cleaning and wall rehabilitation if necessary;
- 3) The decorative polystyrene elements are mounted on the existing wall using a reinforcement mesh and the adhesive chosen according to the type of material used in the masonry;
- 4) To protect the decorative elements, apply primer to reinforce the polystyrene and acrylic or silicone decorative plaster.

Cladding with decorative polystyrene elements is easy to make, it is also more economical in terms of costs which average 15 - 20 euros per 1 m², but the life-span of these types of facades is shorter [16] than when using stone or limestone plywood.
